The Arson Research Project

Fire Pattern Analysis and Case Study Review in Post-Flashover Fires

Abstract

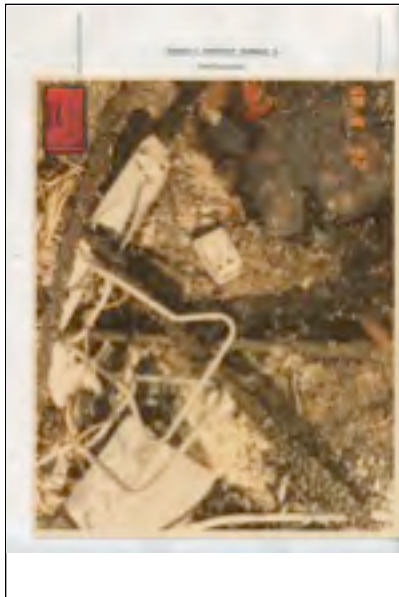
Fire Investigator Porter’s examination of fire scene photographs revealed burn patterns that he described as *pour patterns* which he attributed to an ignitable liquid. He described a photograph of the plywood flooring: *“The first thing it tells us is that we have a definite pour pattern of an accelerant along the edge of the plywood.”* (Porter Testimony, page 966, referring to states exhibit #6) *“The only thing that can cause the fire (pattern) to change from a solid, charred pattern to an area where you just have discoloration for that large an area is going to be if an accelerant’s is present in that area.”*^{xv} (Porter Testimony, page 968)

Photo 1: Low burning to plywood flooring at Graf fire (Exhibit 6)

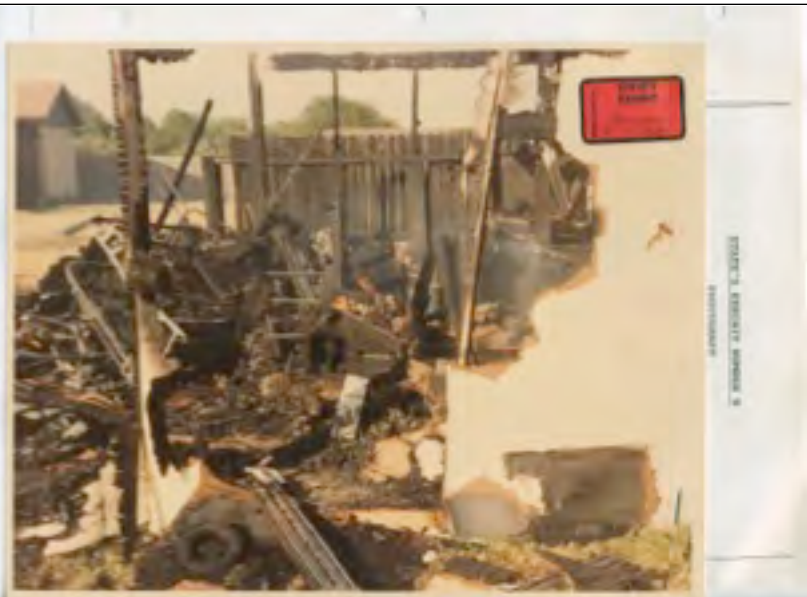
Photo 2: Overall fire damage to the shed at Graf fire (Exhibit 9)

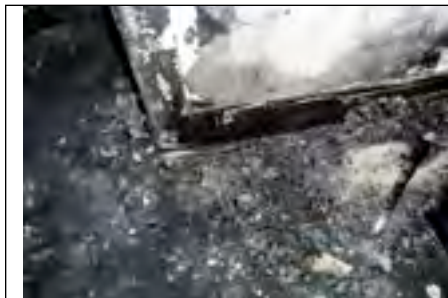
Fire Investigator Vasquez testified that low burning and “pour patterns” led him to believe an ignitable liquid was present: *“Puddle configuration, pour patterns, low char burning, charred floor; the underneath burning of the base board... puddle configurations, in that area, and the total saturation of this floor is indicated with pour patterns, because that’s all I’m doing is looking at the facts, at the evidence. That’s all I’m using. That’s exactly what it is, and the fire was contained to the bedroom and to the hallway...That’s some of the indicators that I came up with.” (255/256)*

Photo 3: Low burning to floors and baseboards at Willingham fire.

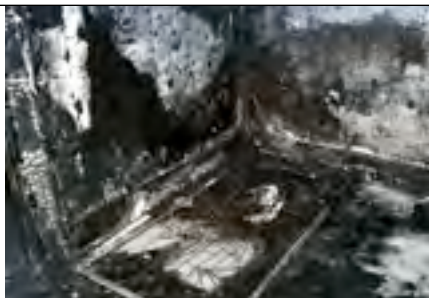
Photo 4: Low burning to floors and baseboards at Willingham fire.

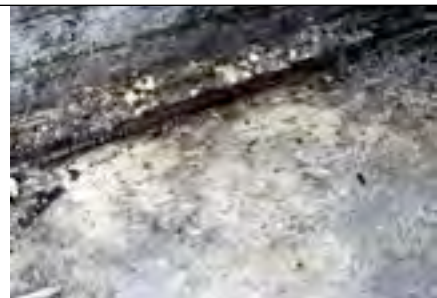
Photo 5: Low burning to floors and baseboards at Willingham fire.

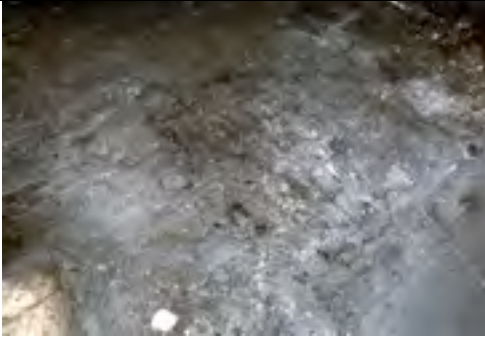
Photo 6: Floor burn patterns to vinyl tile in the Willingham fire.

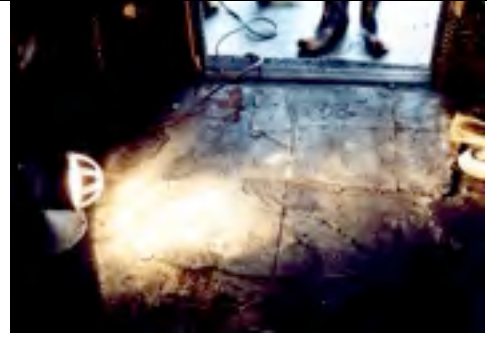
Photo 7: Floor burn pattern to vinyl tile and front door threshold in the hallway of the Willingham fire.

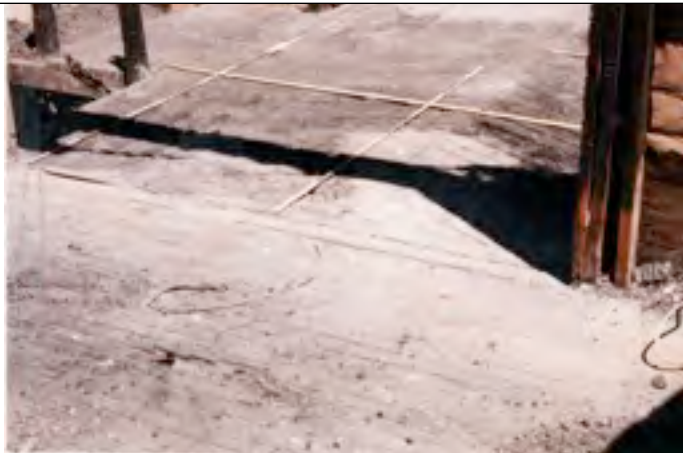
Evers testified that low burning between the wooden pieces that made up the hard wood floor was a particular indicator of an ignitable liquid. *“You can see the gap in the tongue and groove, the heavy charring to the wood, burning down into the subfloor. That’s not a normal fire”*.^{xvi} (Evers Testimony, page 3003)

Photo 8: Floor burn pattern to hardwood floor in the living room of the Souliotes fire.

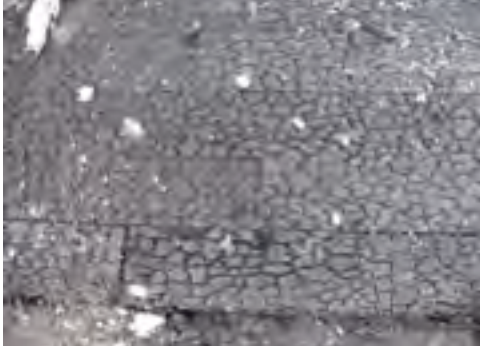
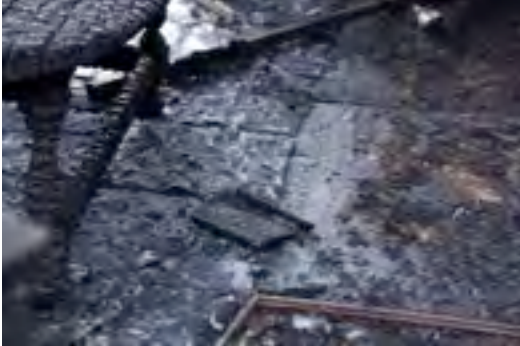
Comparisons of the floor burn patterns throughout each of the four burn cells confirms that flashover conditions are the prime factor in creating irregularly shaped burn patterns on the floor and low burning throughout the room. Ventilation patterns are a major contributor to the location and the severity of burn damage in a flashover environment.

<p>Photo 9: Floor burn pattern to hardwood floor in burn cell #1.</p>	<p>Photo 10: Low burning to furniture and floor burn pattern to vinyl tile and carpet in burn cell #4.</p>

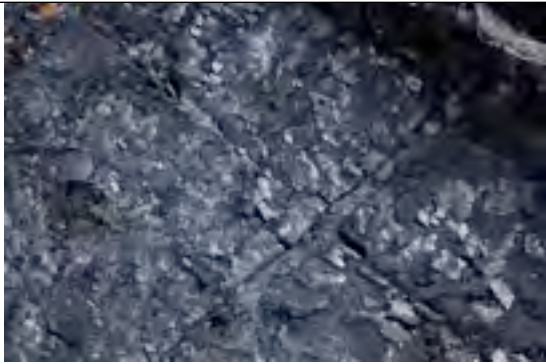
Photo 11: Vinyl tile in burn cell #2.

Vinyl tiles (in Burn Cells #2 and #4) exposed to flashover conditions experienced the type of burn damage and post-burn characteristics described by Evers and Reuscher. The shrinkage, separation and curled edges were present wherever the tiles were exposed to high temperatures, both in the presence and in the absence of a flammable liquid. The burn damage to the vinyl tile documented during the live burn tests was identical to and indistinguishable from the damaged kitchen tiles in the Souliotes fire.

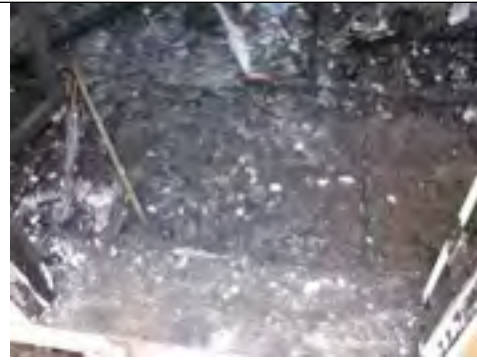
Photo 12: Vinyl tile in the door way of burn cell #4.

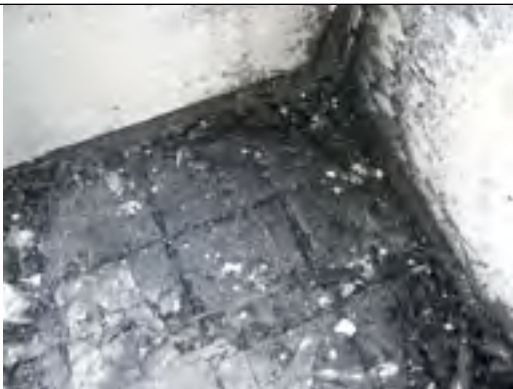
Photo 13: Low burning to baseboards and vinyl tile in burn cell #4.

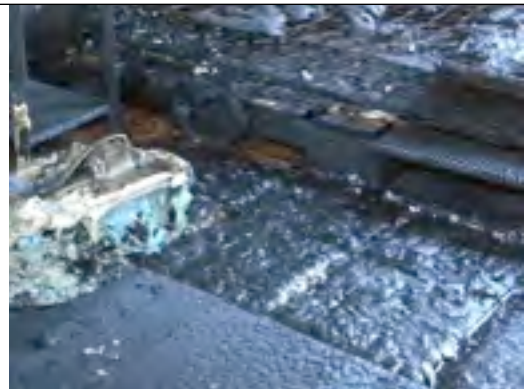
Photo 14: Low burning to furniture and vinyl tile in burn cell #2.

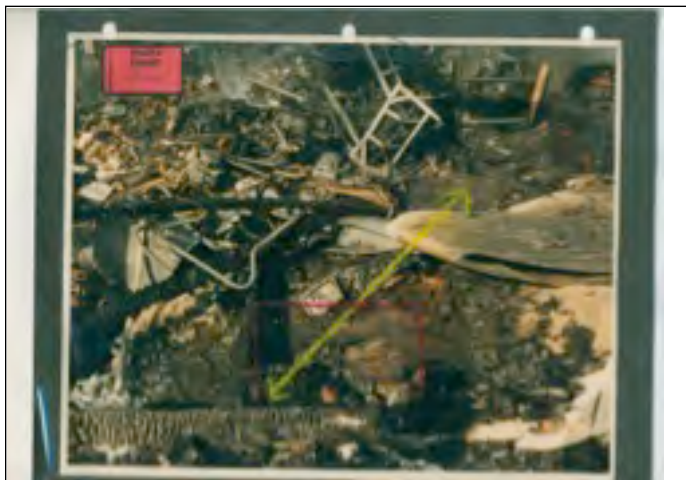
Fire Investigator Porter testified to the presence of two holes in the flooring of the shed that were visible in scene photographs and implied they were the result of an ignitable liquid. (Porter Testimony, pages 1104, 1105)

Photo 15: Low burning and hole in plywood subfloor at Graf fire (Exhibit 71)

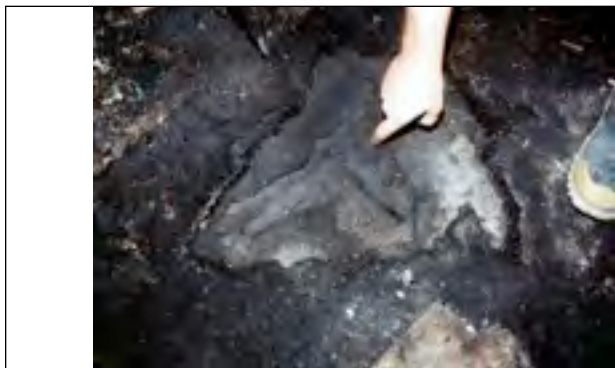
Burn patterns to the floor in the center of the northeast bedroom included burning through the carpet, vinyl tile and plywood sheeting, exposing a wooden subfloor material, without completely penetrating the floor.

Photo 16: Burn damage to floor in the northeast bedroom of the Willingham fire.

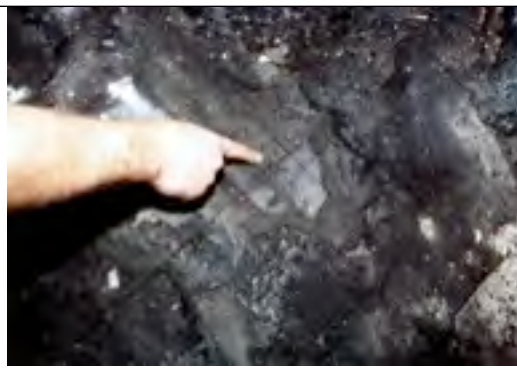
Photo 17: Burn damage to floor in the northeast bedroom of the Willingham fire.

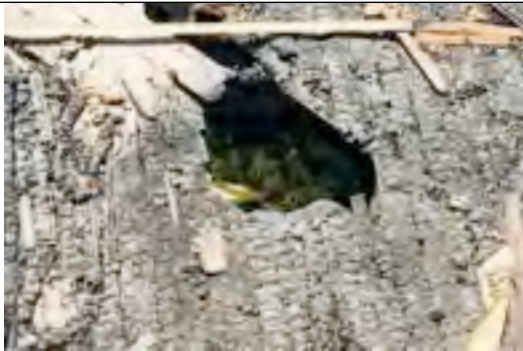
Bob Evers described a photograph depicting several holes burned through the living room floor: “*In my experience this is a classic example of an ignitable liquid being poured on the floor, the damage that you see*”. (Evers Testimony, page 8488)

Reuscher described holes burned in the living room floor as “*...an indication of flammable liquids being poured on the floor used as an accelerant*”. (Reuscher Fire Investigation Report, page 8)

Photo 18: Hole burned through the living room floor of the Souliotes fire.

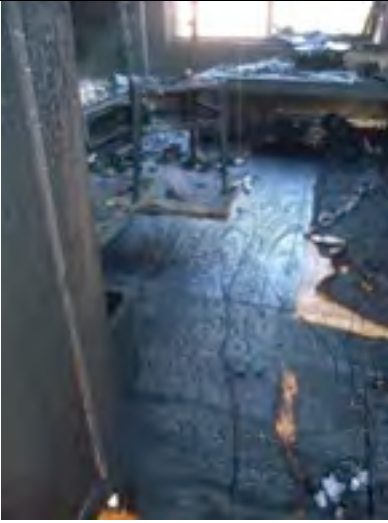
Alligator char, the burn pattern described by Investigator Porter in determining the presence of abnormal heat in the Graf case, was present in each of the four burn cells. Virtually every exposed wooden surface in each of the four burn cells experienced some amount of fire damage that would meet Investigator Porter's description of *alligator charring*.

Photo 19: Floor burn patterns to plywood sheeting of burn cell #3.

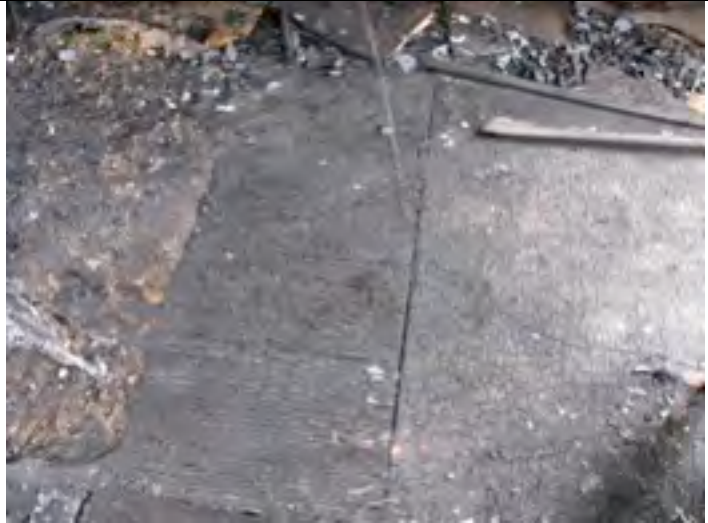
Photo 20: Floor burn patterns to plywood sheeting of burn cell #2.

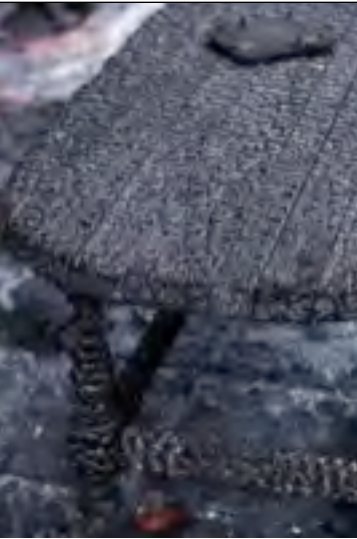
Photo 21: Low burning to wooden table in burn cell #4.

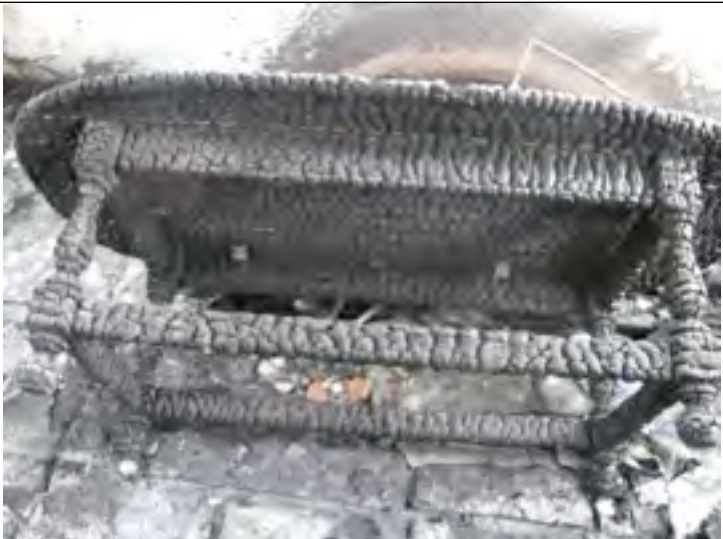
Photo 22: Low burning and burn patterns to underside of wooden table in burn cell #4.
